# Honeoye Lake Watershed Task Force Newsletter

# 2023 State of the Lake

# 2023 Update on the Honeoye Lake Aeration Engineering Planning Project and the NYS DEC Honeoye Lake Nutrient Inactivant Pilot Study

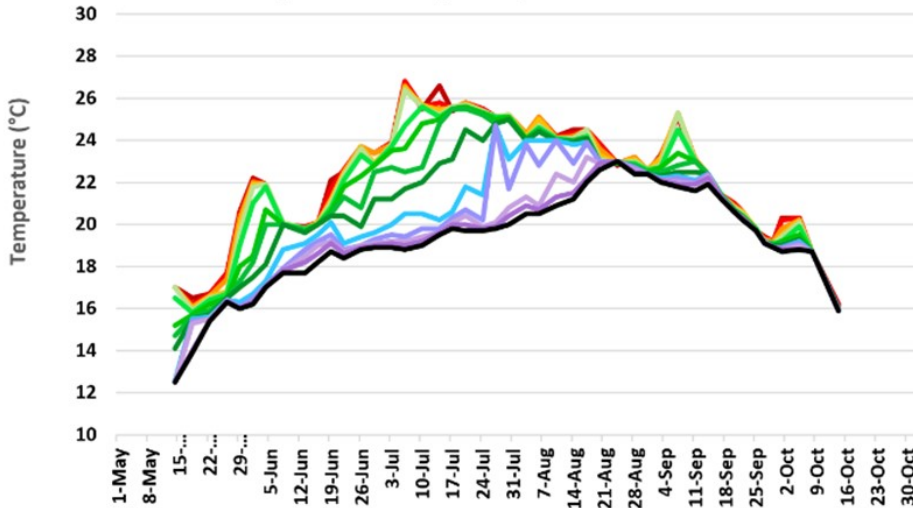
### Honeoye Lake Deep Temperature 2023

Following an unusual winter with little ice cover, Honeoye Lake returned to a near normal seasonal temperature profile, reaching a peak of 27 degrees Celsius (~80 F) at the surface in early July. Heat gained at the surface was transferred downward by an unusual amount of seiche activity (internal waves), seen from late July through late August in the charts to the left. Notice the volatility of the 7 meter (23 feet deep) blue lines. The lake also had two complete summer mixing events: the first during the third week of August and the second in mid-September. Complete mixing events are depicted in the charts where the black line (30 feet deep) converges with all other depth lines, indicating the lake depths are uniform in both temperature and dissolved oxygen. Each partial or complete mixing event will bring phosphorus released from deep sediment when the lake was stratified and the bottom anoxic, into the water column and potentially to the surface fueling our blue-green algal blooms.

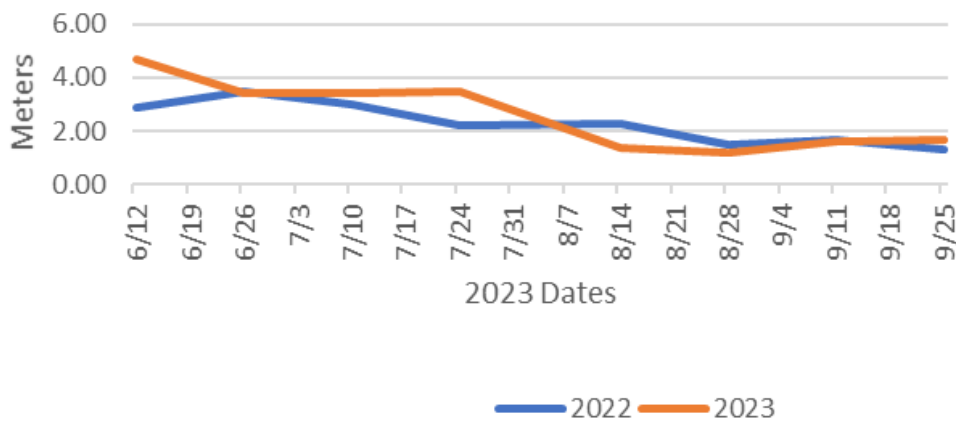
### 2022-2023 Secchi Disk (Water Clarity) Readings

The Lake's secchi disk readings (water clarity) in 2023 were very similar to 2022. Water clarity is affected by turbidity and the density of algae in the water column. See chart on the left.

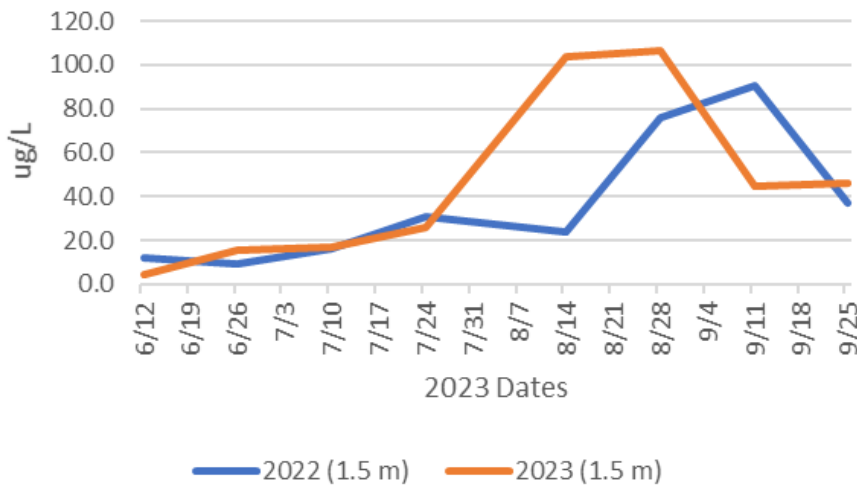
### 2022-2023 Chl-a (Algae)

The pigment chlorophyll-a is a measure of algal abundance. The greatest amounts of algae this year occurred from late July through late August. This was also the time when weekly lake mixing events and one complete lake mixing event occurred. In 2022 the highest amount of algae occurred late August through mid-September. The 2023 peak algae level was ~100 ug/L versus a 2022 peak of ~90 ug/L.

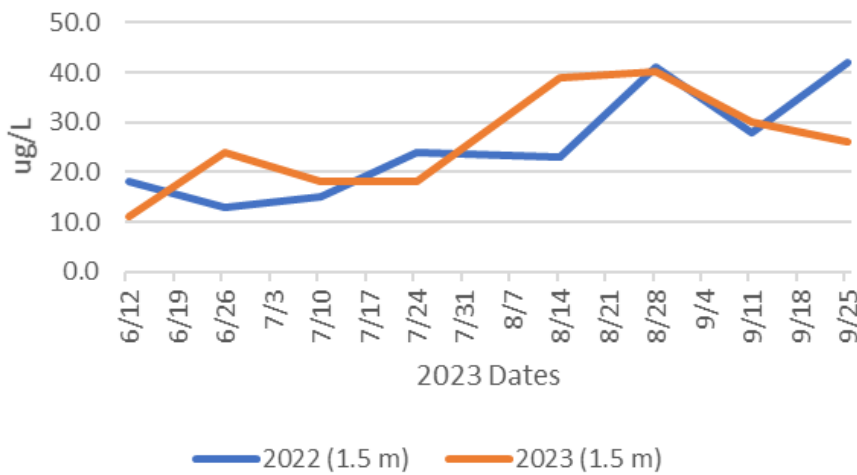
### 2022-2023 Surface Total Phosphorus

The highest amounts of phosphorus in the surface water in 2023 occurred from late July through late August. This was also the time of weekly lake mixing events and one complete mixing event. In 2022 the highest amount of surface phosphorus occurred briefly in late August and late September. The 2023 and 2022 peak surface phosphorus levels were both ~40 ug/L.

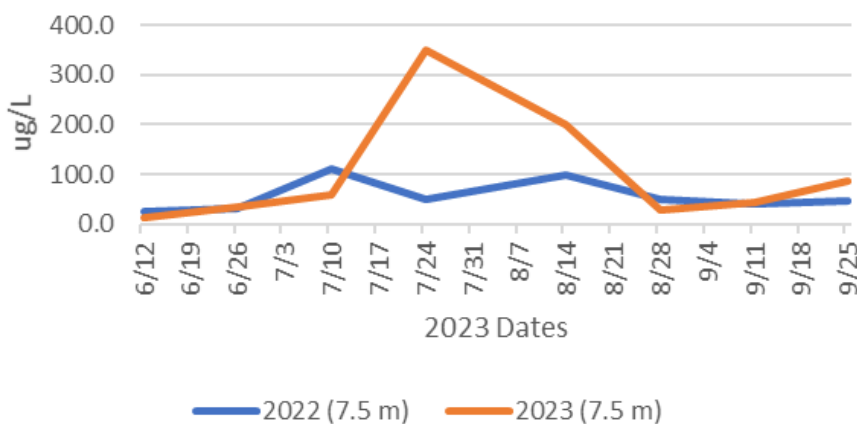
### 2022-2023 Deep Total Phosphorus

In 2023 the lake was stratified for all of July. This accounts for the spike in Total Phosphorus at the bottom in 9m (~30 feet) of depth in late July 2023 when weekly seiche generated partial mixing events started occurring. In 2022 the first mixing event happened in early July and the second mixing event did not happen until mid-August. The 2023 peak deep phosphorus level was ~350 ug/L and in 2022 the peak deep phosphorus level was ~100 ug/L. However, we have seen deep phosphorus levels as high as ~350 ug/L in previous years.

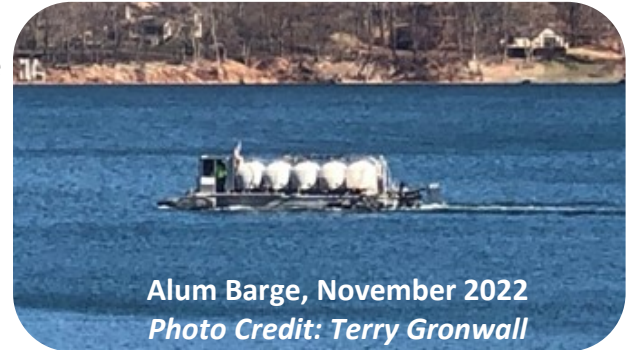
Alum Barge, November 2022  
Photo Credit: Terry Gronwall

In September 2022, NYS Department of Environmental Conservation (DEC) announced plans for a Nutrient Inactivant (Alum Treatment) Pilot Study in Honeoye Lake. In recent years, DEC conducted alum treatments on two small lakes in the Lower Hudson Valley to assess impacts of alum treatments on phosphorus levels and lake ecosystems. The Honeoye Lake Alum Treatment was positioned as DEC's first large-lake pilot study. DEC has been conducting these pilot studies as the agency evaluates a potential permitting process for the use of Alum Treatments since they are not currently allowed in New York State. The Honeoye Lake Alum Treatment was completed in November 2022.

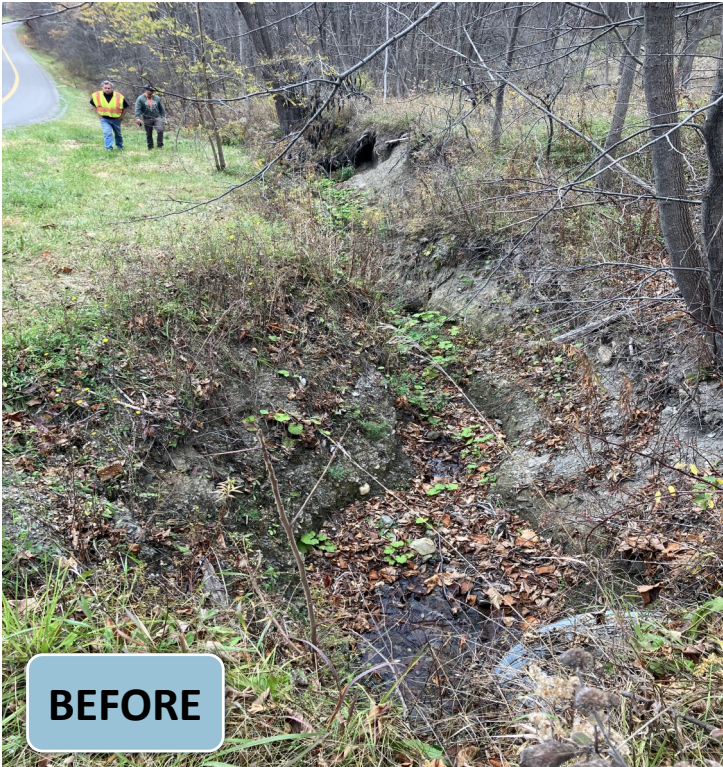
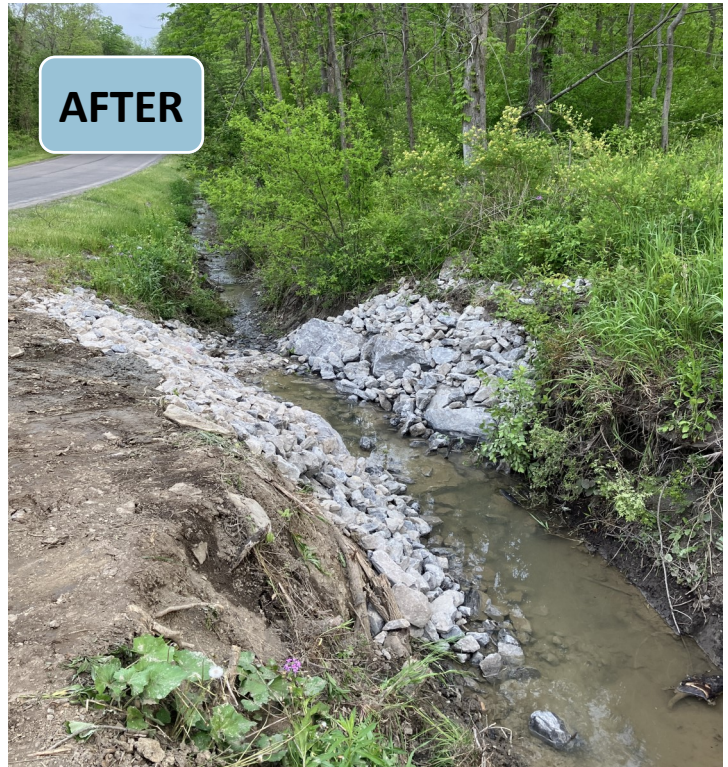
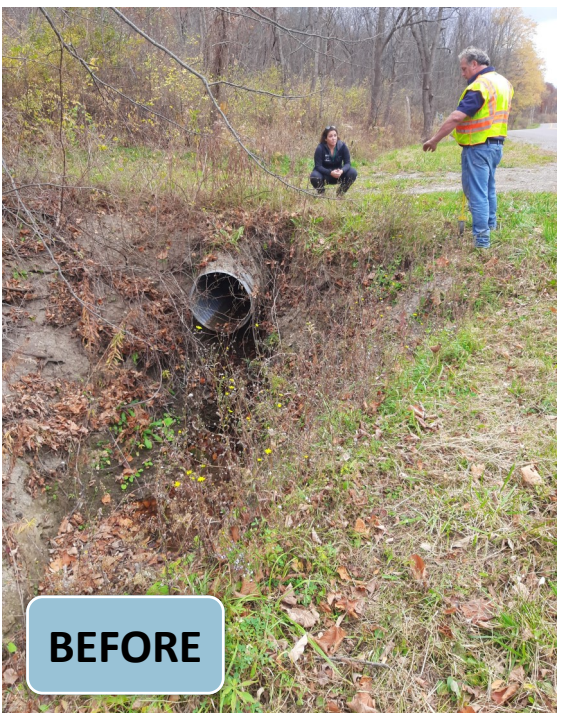
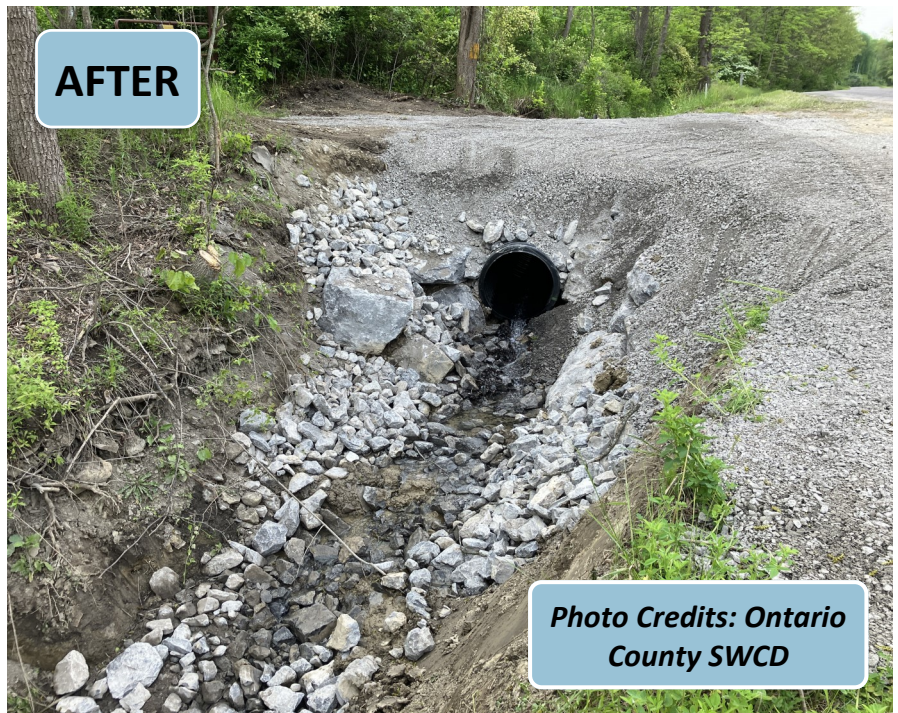
The Ontario County SWCD provided technical assistance to the Town of Richmond and funding through the Finger Lakes-Lake Ontario Watershed Protection Alliance (FLOWPA) for a road ditch stabilization project in the Town of Richmond along East Lake Road. This road ditch had become unstable and was leading to severe erosion resulting in sediment and nutrient loss from the site. The Town of Richmond Highway Department replaced the existing driveway culvert pipe and installed two grade control structures utilizing large rock to help provide stabilization. This stabilization will reduce erosion and sediment loss from the area therefore decreasing the amount of sediment and nutrients entering Honeoye Lake.

**BEFORE**

**AFTER**

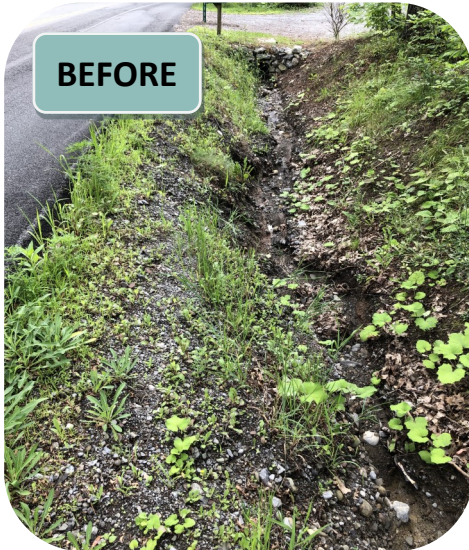
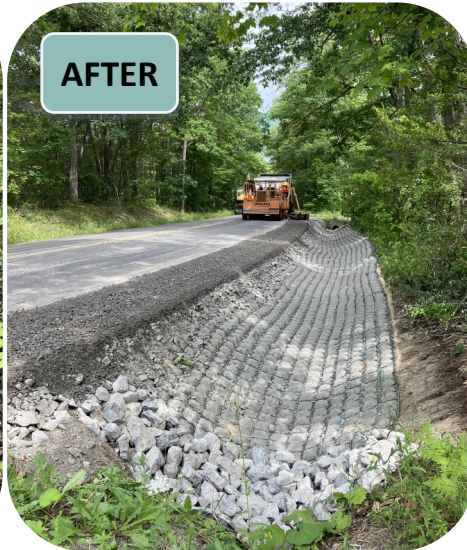
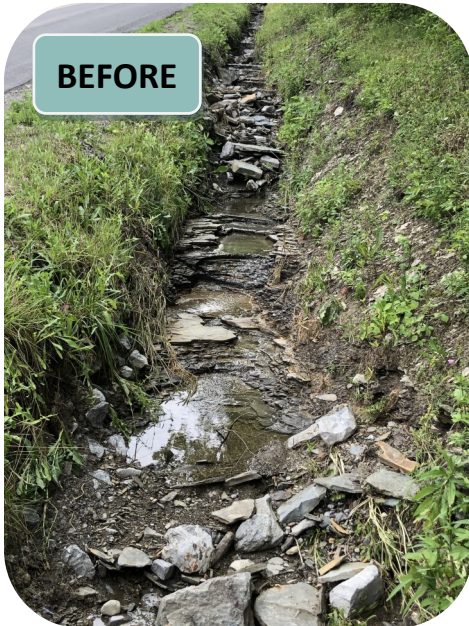
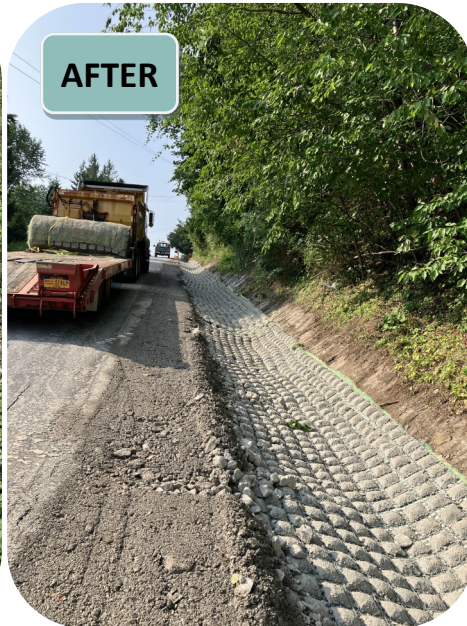
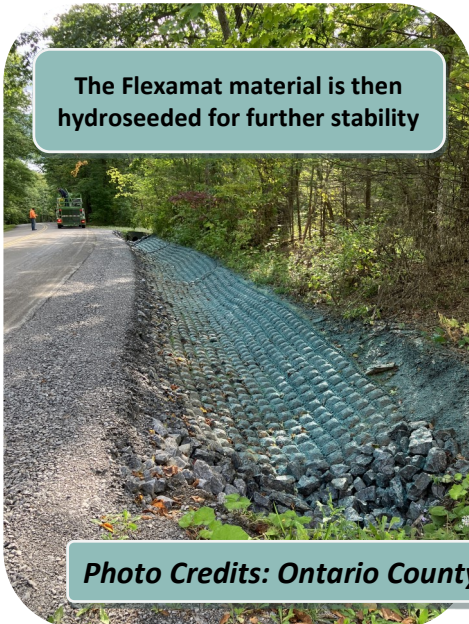
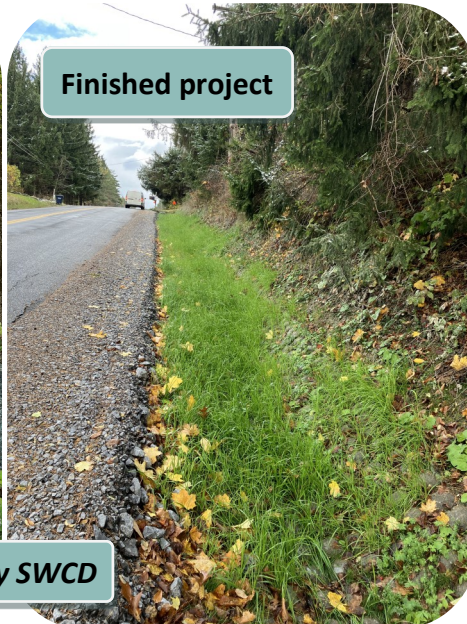
Ontario County SWCD partnered with the Town of Canadice Highway Department to stabilize several ditches experiencing severe erosion along Cratsley Hill Road, Jersey Hill Road and Canadice Hill Road. Erosion from steep roadside ditches, such as these, has a direct effect on the water quality in Honeoye Lake. Nutrients are bound to sediments and when erosion occurs and washes these sediments downslope they accumulate in our waterbodies and can help fuel the occurrence of Harmful Algal Blooms (HABs). These particular sites were stabilized using a material called Flexamat, a permeable mat made of woven material overlaid with concrete blocks in a grid pattern. This provides the stabilization needed to withstand flows from stormwater during major rain events while also leaving space between the blocks for vegetation to establish. This vegetation helps to further stabilize the road ditch while also filtering and slowing water. Funding for this project was made possible through the New York State Department of Environmental Conservation Water Quality Improvement Program with match funding coming from the Town of Canadice in the form of labor and equipment. This project is part of a larger, ongoing effort in the Honeoye Lake Watershed to reduce sediment and nutrient loss from roadside ditches. Thank you to the Town of Canadice Highway Department for their expertise in completing these projects and the Ontario County Highway Department for hydroseeding!

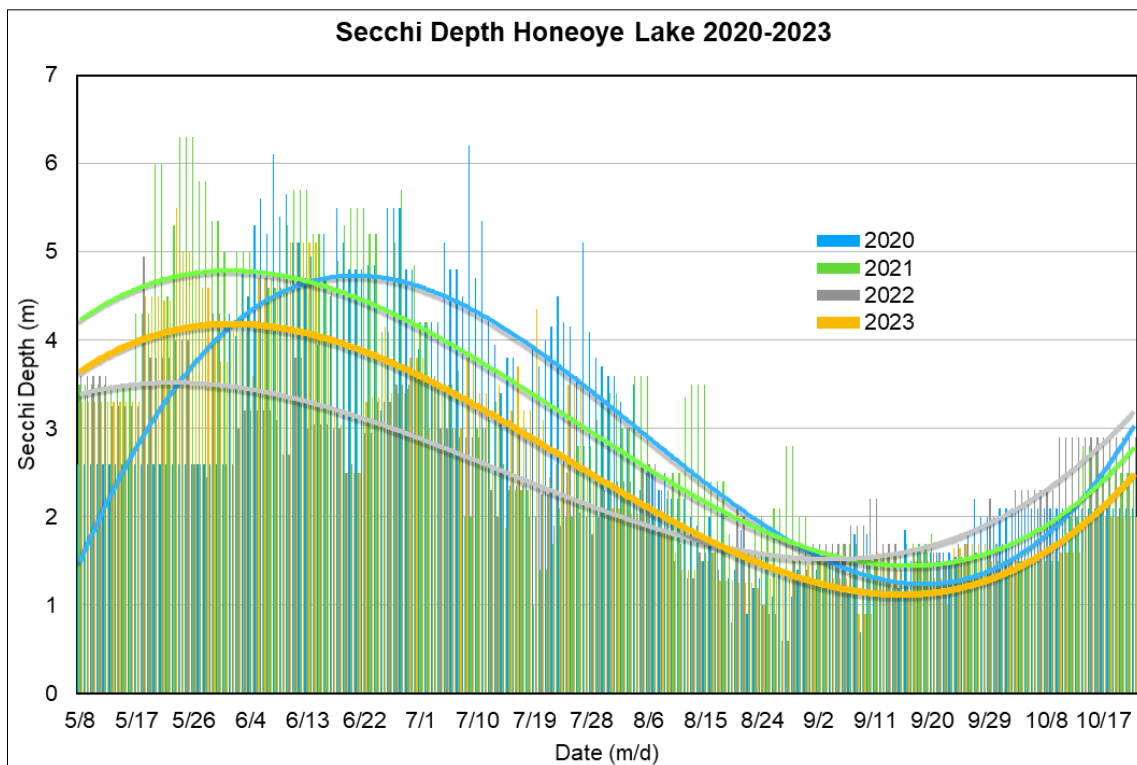
2023 marked the 7<sup>th</sup> year of the Honeoye Lake Secchi Disc Program. Volunteers collected 132 samples over a 5-month period beginning May 14, 2023 and ending October 14, 2023. The Secchi disc is used to measure water clarity which is affected by turbidity, primarily from runoff, or algae. For Honeoye Lake, algae is the dominant factor affecting water clarity. Water clarity in 2023 followed a pattern similar to the pattern seen in previous years. Water clarity is high in spring and early summer, gradually decreasing as water temperatures rise and dissolved oxygen is depleted, whereby creating an environment conducive to algae growth. Spring of 2023 showed slightly more clarity than spring of 2022, but not quite as much as in 2021 or 2020. Water clarity reaches its lowest around mid-September then slowly improves as fall approaches.

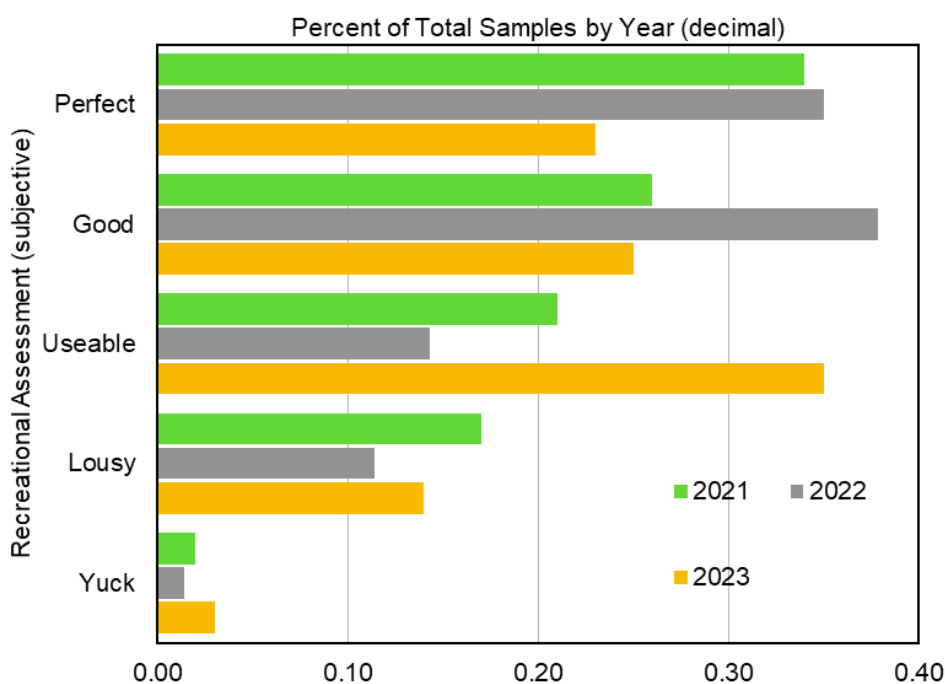
## Volunteers’ Lake Recreational Enjoyment Assessment

scum (10% of samples in 2023 vs. 7% average in 2020 -2022). The good news is that 83% of the samples were reported as “perfect”, “good” or “usable” for recreational enjoyment. The New York State Department of Environmental Conservation will continue to monitor the outcome of their alum treatment project at Honeoye Lake. The Secchi disc data is extremely useful information in order to evaluate the results.

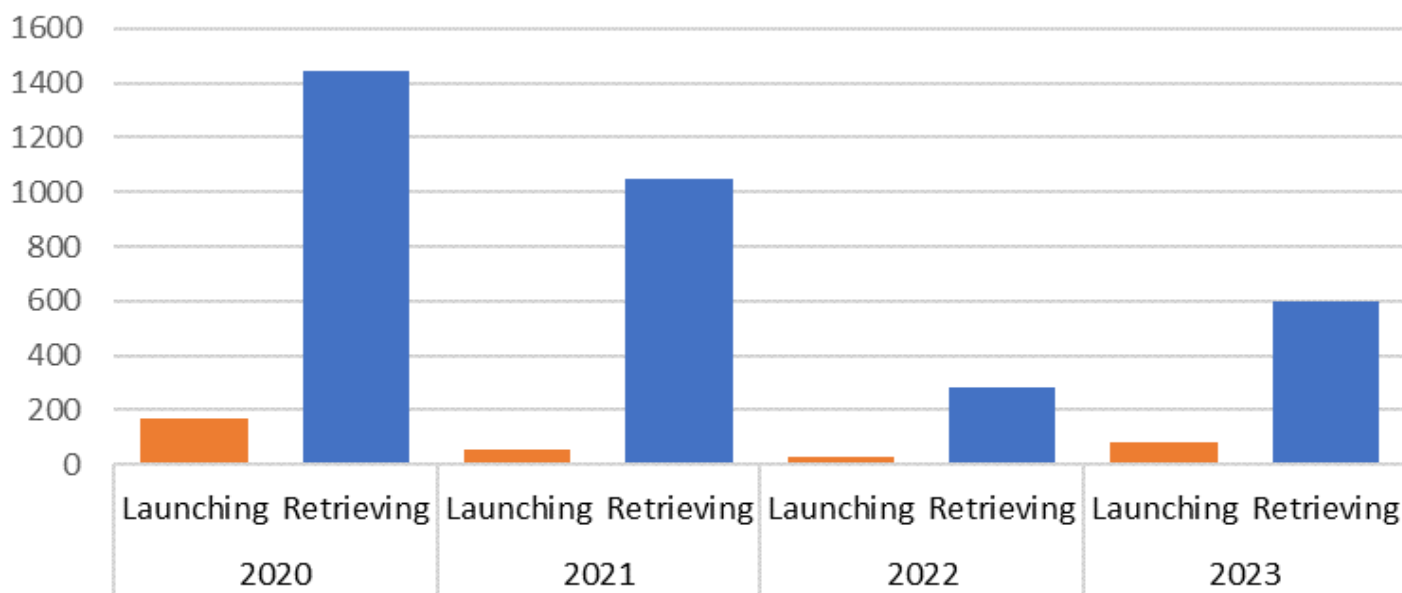
### Total Detections of the 3 Most Common Invasive Species on Inspected Watercrafts

**Figure 1: Total Detections of the top three most common invasive species (Eurasian watermilfoil, curly-leaf pondweed, and zebra mussel) separated by launching and retrieving watercraft over the past four years. Stewards are more likely to detect AIS on retrieving watercraft.**

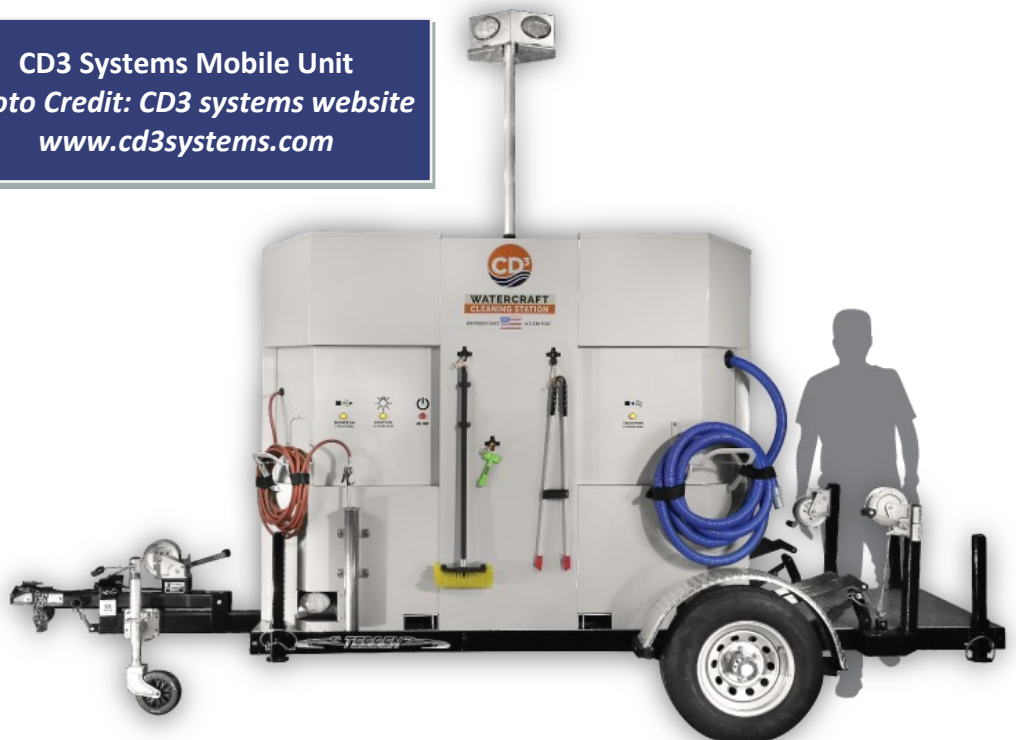
The CD3 Systems cleaning facility to be employed at Honeoye Lake is a self-service, solar powered unit with a combination of tools including compressed air and a vacuum to help boaters voluntarily do their part to help stop the spread of aquatic invasive species. There will be no cost to use the wash unit and a public outreach effort will include multiple partners to help get the word out and encourage boaters coming and going to Honeoye Lake to clean their watercraft. One target audience for this outreach effort is fishing derby organizers and participants. The wash unit will also complement the work of the watercraft stewards who are stationed at the launch on a part-time basis through the summer providing in-person education and boat inspection for AIS. The wash unit will add a resource available to boaters, especially when stewards are not on duty.

**CD3 Systems Mobile Unit**  
*Photo Credit: CD3 systems website*  
[www.cd3systems.com](http://www.cd3systems.com)

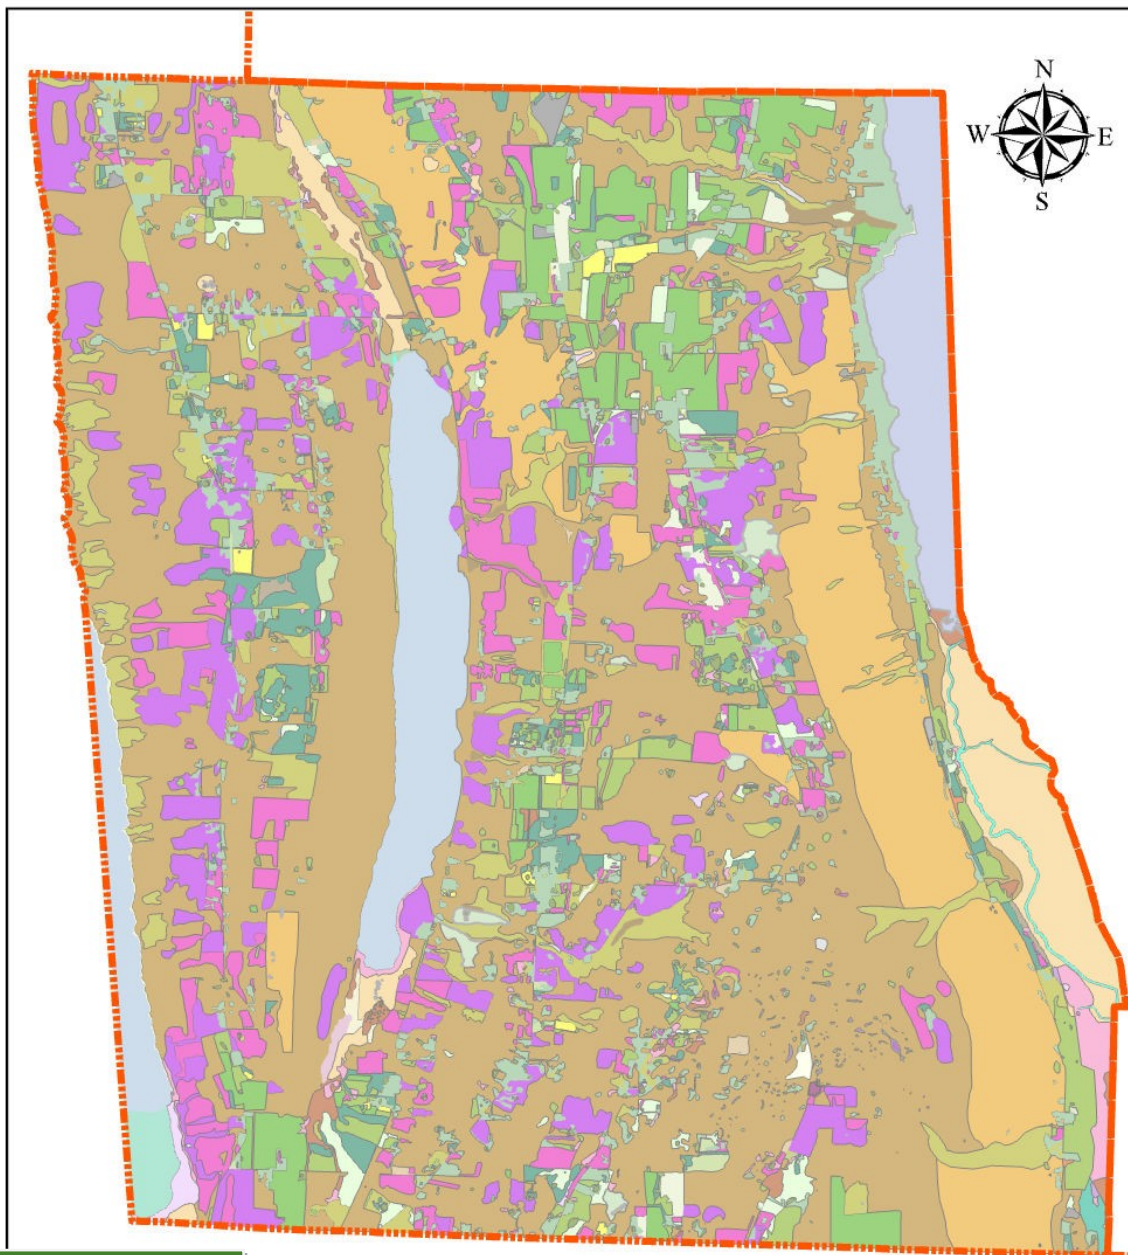
# Town of Canadice Land Use/Land Cover Update 2023

Ontario County, NY  
Produced by the Ontario County Planning Department  
2023
